UNI-3049

August 9, 1985

115-F GAS RECIRCULATION BUILDING
INDIVIDUAL FACILITY DECOMMISSIONING REPORT

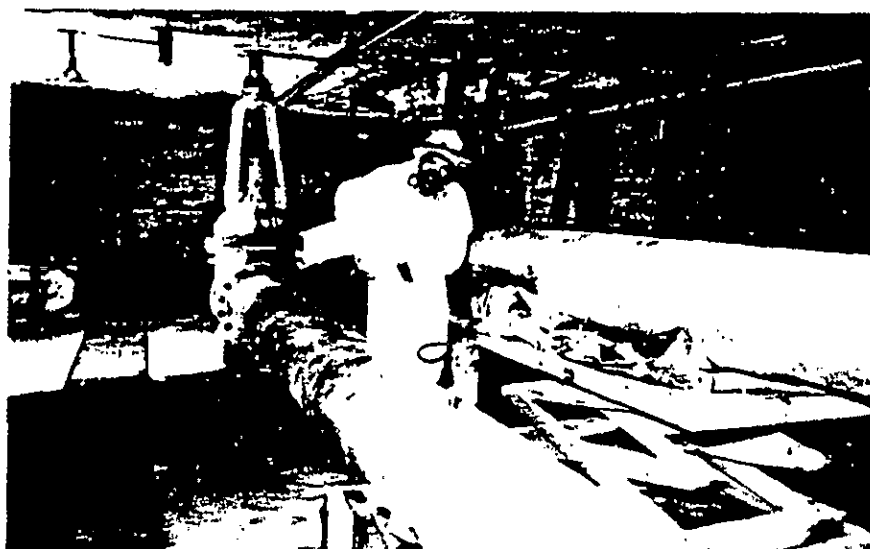
Figure 4-2. Pipe Removal Dolly.

Dolly extended.

Dolly in use.

Two special handling dollies (Figure 4-2) were designed and fabricated to handle the pipe in the tunnel. One dolly was designed to slide under and support the 16-inch pipe (located 11 in. (28 cm) above the tunnel floor) during cutting, then roll sectioned pipe under the access opening for removal. The other dolly had a hydraulically operated scissor lift table that could be raised 41 in. (104 cm) to support the higher mounted 16-inch piping during cutting.

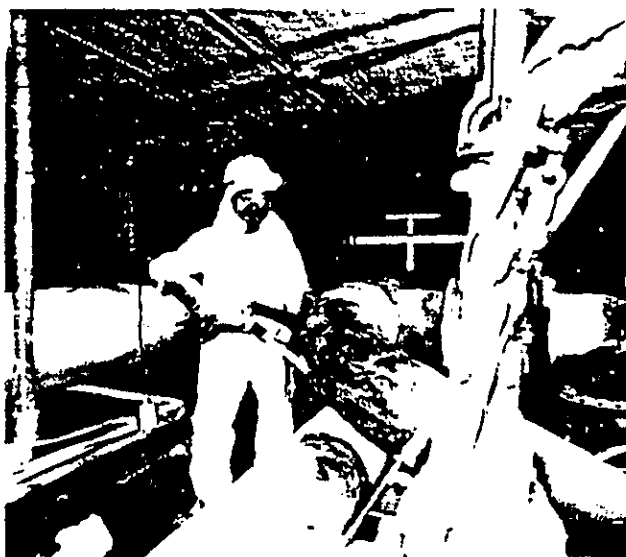
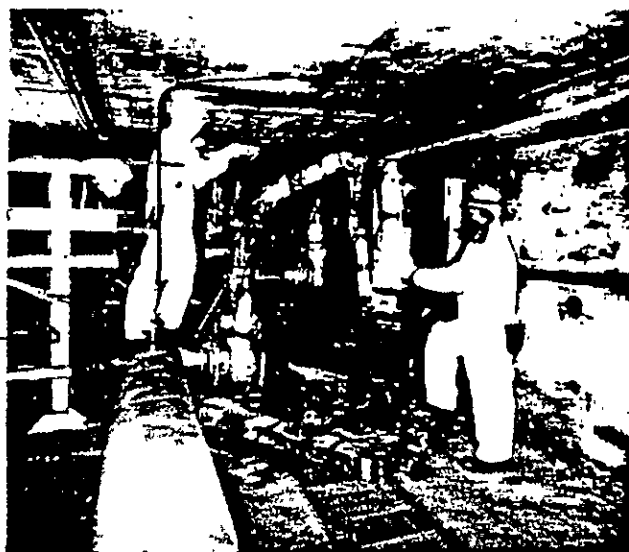
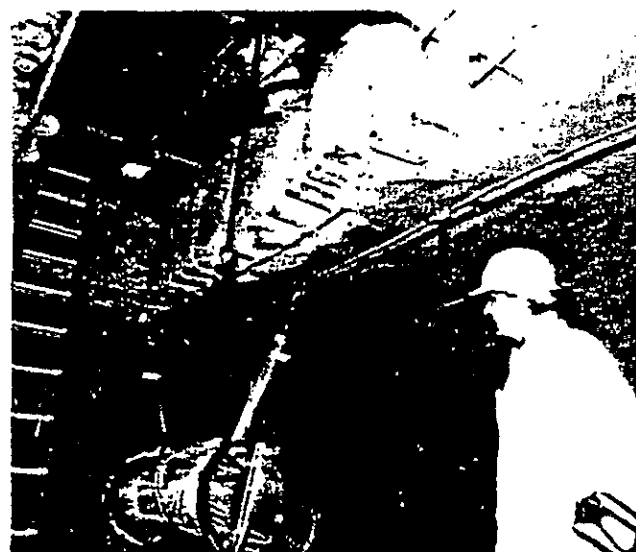
Figure 4-3. Pipe Removal from the 115-F Tunnel.

1. Pipe being cut into 6 ft lengths.

2. Supporting pipe before sectioning.

3. Valve removal using hydraulic floor crane.

4. Pipe removal through tunnel access hole.

A mechanical cutting method was selected for cutting out the 6-ft (2 m) pipe sections (Figures 4-3 and 4-4). Oxy-acetylene cutting was ruled out due to the encumbrance of the necessary breathing air equipment in such confined quarters and the distances involved.

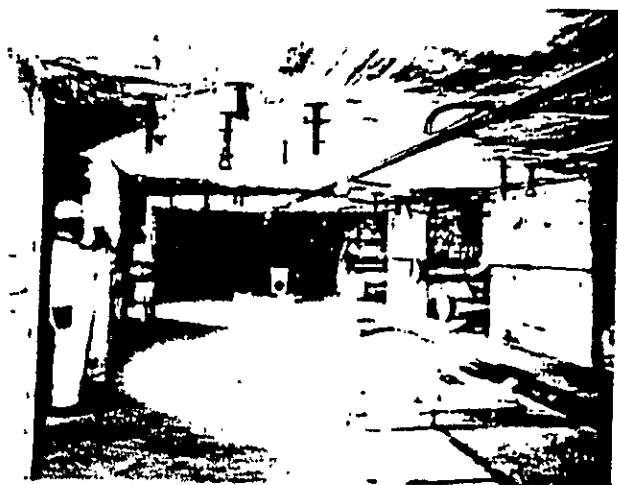
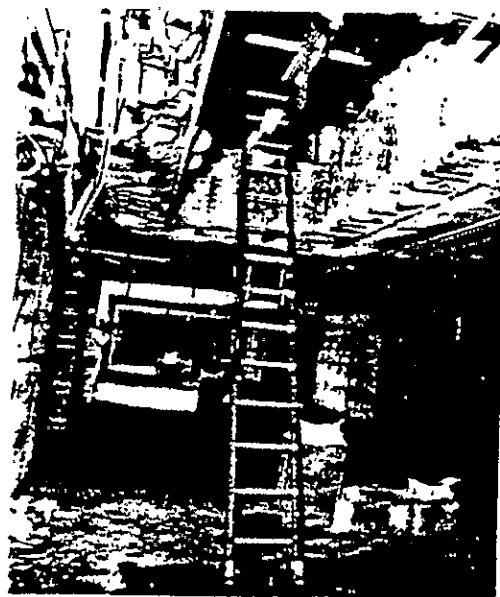
Figure 4-4. 115-F Tunnel Before and After Pipe Removal.

Tunnel before pipe removal.

Tunnel after pipe removal.

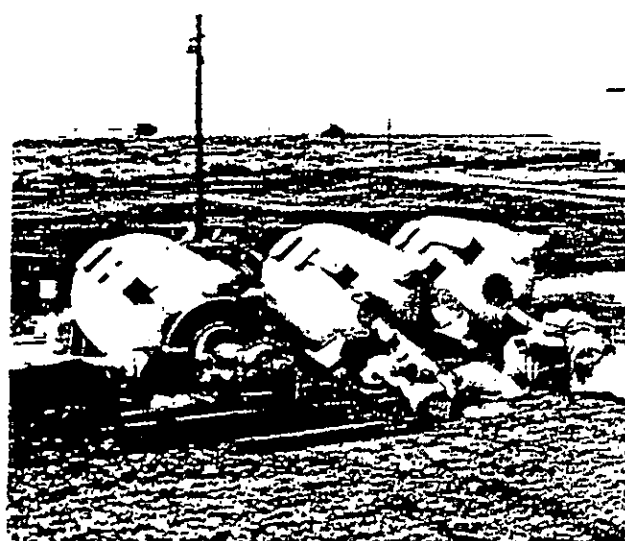
Figure 4-5. Equipment Removal.

1. Dryer room before equipment removal.

2. Piping and equipment partially removed.

3. Access for silica-gel tank removal.

4. Silica-gel tanks awaiting disposal.

The equipment located in the dryer rooms (Figure 4-5) was disassembled or cut out in manageable sections. The condenser separator, precooler, and heater and interconnecting piping were wrapped with polyethylene sheeting prior to removal or immediately upon removal.

The silica-gel drying towers were 7-ft (2.1 m) diameter tanks each containing an average of 6.3 curies of radioactive material. The 12-inch inlet and outlet lines were disconnected. Then blank flanges were installed to contain the silica-gel. The towers were hoisted off their 4-ft (1.2-m) high concrete supports and lowered to the floor. All packaged equipment was removed from the cell by knocking out the brick-filled access in the dryer room exterior wall.

The two 6-ft x 6-ft gas filters were removed similarly to the silica-gel towers. Blank flanges were installed and the filters were removed through exterior wall openings. Noncontaminated material that was removed for accessibility along with clean building rubble, was disposed of in the 183-F clearwells. The contaminated equipment removed from the 115-F Building was shipped to the Hanford 200 West contaminated waste disposal facility.

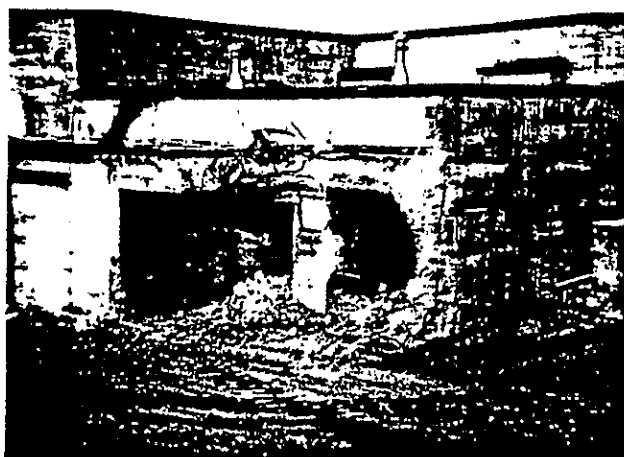
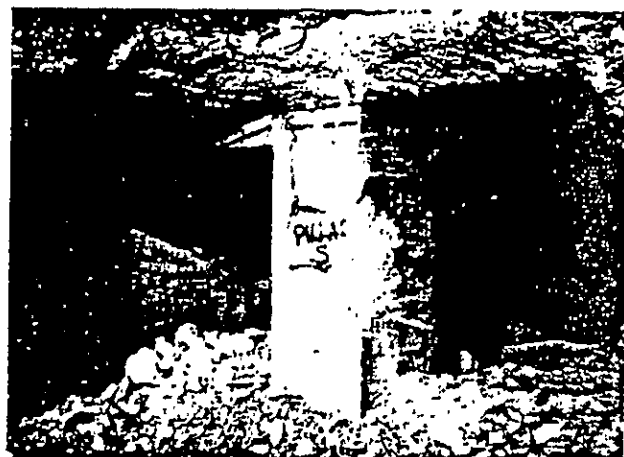
Figure 4-6. 115-F Demolition Assessment.

1. Southeast corner before demolition.

2. Wrecking ball begins demolition.

3. Southeast corner demolished.

4. Closeup showing thickness of concrete walls.

The demolition of the 115-F Gas Recirculation building was started and completed during the last quarter of FY 1984, after completing a demolition approach assessment. The demolition assessment effort began at noon January 16, 1984 using a 60-ton Linkbelt crane and a 5-ton wrecking ball on the southeast corner, which was one of the strongest sections of the building. Both the east and south walls were 3 ft (1 m) thick and heavily reinforced with 1/2-in. and 5/8-in. rebar (Figure 4-6). Several hours of beating were required to weaken this corner, but once broken, work progressed more rapidly. The rebar was cut as required to remove the rubble. Prior to demolition, the SE corner area was gridded in 100 cm² areas, surveyed and sampled. No contamination was found.

The concrete demolition took 4 hours to complete and the cleanup took another 4 hours. The debris and rubble were loaded into a 15-yd dump truck using a Hough front loader, and then trucked to the 100-F clearwell for disposal.

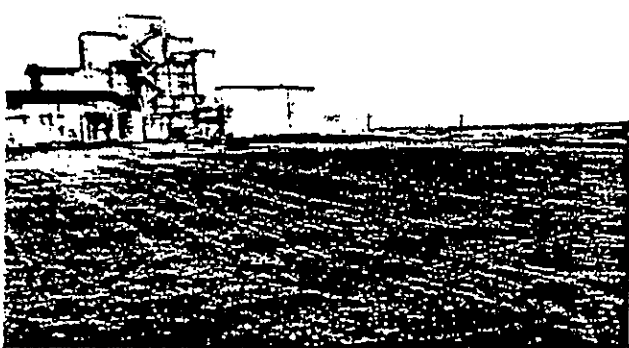
Figure 4-8. Demolition of 115-F (SE View).

1. 115-F before demolition.

2. Demolition about 50% complete.

3. Demolition about 85% complete.

4. Final site grading completed.

Demolition work started on the uncontaminated west end of the building on July 6, 1984 and completed in October 1984. Of this 12-week period, equipment downtime for maintenance and repairs accounted for 3 weeks. Figures 4-7 and 4-8 show the demolition.

The below-grade perimeter walls, which extend down 13 ft (4 m) below grade, were demolished down to 3 to 4 ft (1 to 1.2 m) below grade. The remaining walls were left intact and serve as containment for the building rubble. The entire area was covered with clean backfill material. This overburden averages 4 to 5 ft (1.2 to 1.5 m) in depth and exceeds the ARCL requirement for 1 m of clean backfill. In addition, grading the final site to be compatible with the surrounding terrain added another 3 to 4 ft (1 to 1.2 m) of clean backfill over the site.
